**Sub: CC.93/2024/TG-RERA – Meeting to Resolve  
Construction Defects.**

**Report on Issues Related to Expansion Joints and Water Leakage**

**Report on the Condition of the Building Corridor and Water Seepage**  
**Issues**

**Report on the Condition of the 1<sup>st</sup> Level Basement Parking**

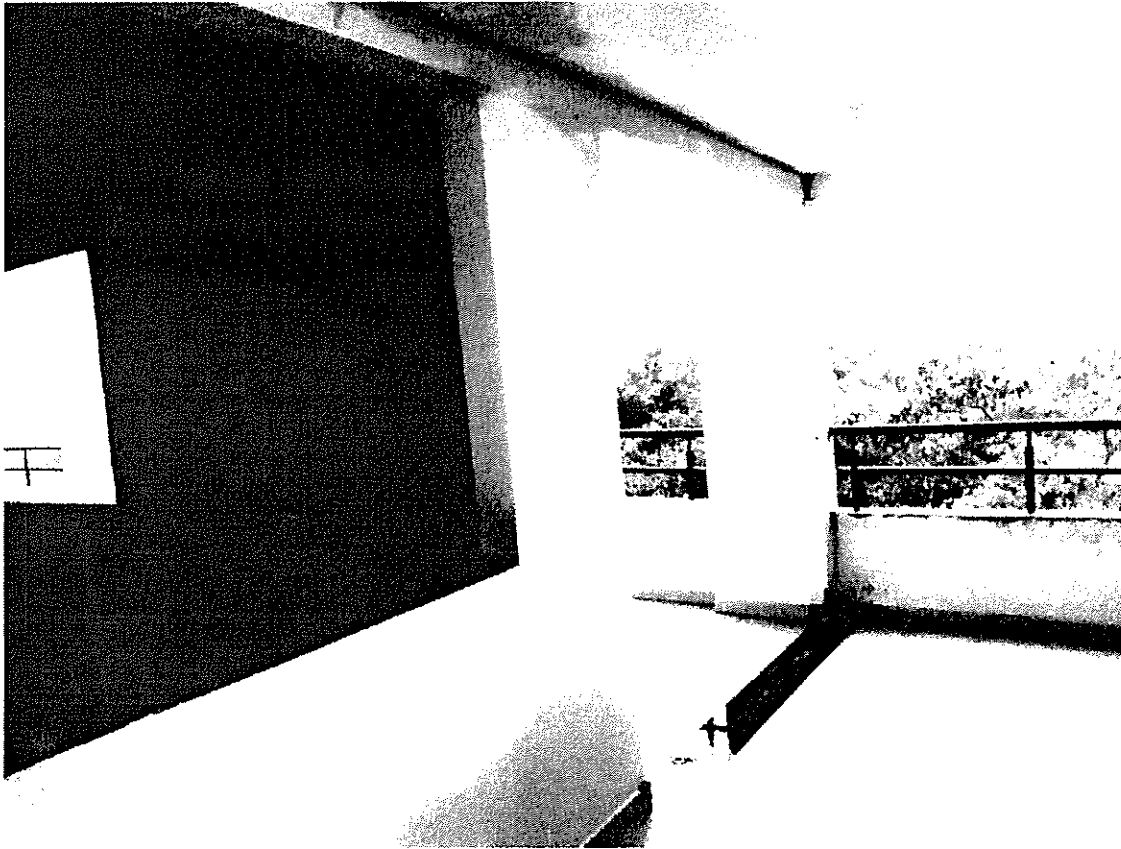
During the rains (even for small-intensity rainfall), water penetrates through the poorly constructed expansion joints. The infiltration of water weakens the surrounding structural elements, causing potential long-term damage, including corrosion of reinforcement, damp patches on walls, and weakening of floors. Photos are attached for your reference (**Refer to Annexure A**).

After the residents filed a complaint under the Real Estate Regulatory Authority (RERA), the builder attempted to repair the joints by using white cement and granite. This method is not suitable for sealing expansion joints, as it neither provides the flexibility required to accommodate structural movement nor offers adequate waterproofing.

Such an approach is deemed ineffective and could potentially worsen the problem by trapping moisture within the structure, leading to accelerated damage.

One effective and durable solution for arresting water seepage through expansion joints is the application of flexible waterproof expansion joint sealant. These sealants are designed to provide both waterproofing and flexibility, allowing the joint to accommodate structural movement without cracking or letting water through.

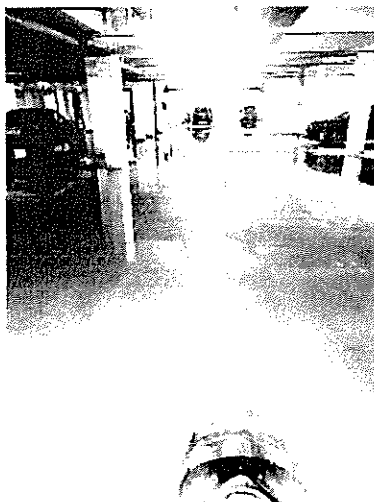
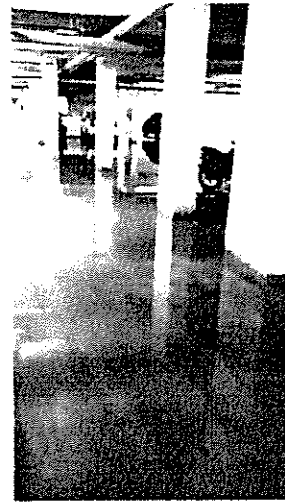
**Attachments:**

1. The primary issue observed is water accumulation in the entire 1st level basement. There is no visible provision for effective drainage of rainwater.

2. The stagnant water depth varies between 6 to 7 cm, indicating that the surface is almost uniformly flat, without the necessary slope required for water runoff.

4. Upon inspection, it is evident that the slope necessary to direct rainwater toward drainage points was not adequately implemented. Basement floors typically require a slope gradient of at least 1-2% toward designated drains to prevent water from pooling.

5. The absence of proper slope compromises the functionality of the drainage system, if one exists.
6. There are either no visible drainage outlets in the parking area, or if drains are present, they are ineffective due to the flat floor layout. This could lead to clogging, poor maintenance, or improper installation of the drainage system.

1. A professional contractor should be engaged to regrade the entire basement floor to provide an appropriate slope toward existing or newly installed drainage outlets. The slope should be at least 1-2% to ensure effective water flow.
2. If not already in place, install a comprehensive drainage system that includes floor drains at strategic locations throughout the basement, connected to stormwater management systems.
3. Regular maintenance and cleaning of drainage outlets to prevent clogging.
4. Waterproofing of basement walls and floors should be reviewed and repaired where necessary. This might include the application of waterproof membranes, sealing of joints, and injecting chemical waterproofing agents where seepage is evident.
