Sub: Crescentia and NRK cable laid - MN park premises Pending Works Inspection report - Reg.,

As per joint inspection done with Mr. Satyanarayana (MN Park) dated 25-06-2024, following observations have been noted and need to be attended from our side.

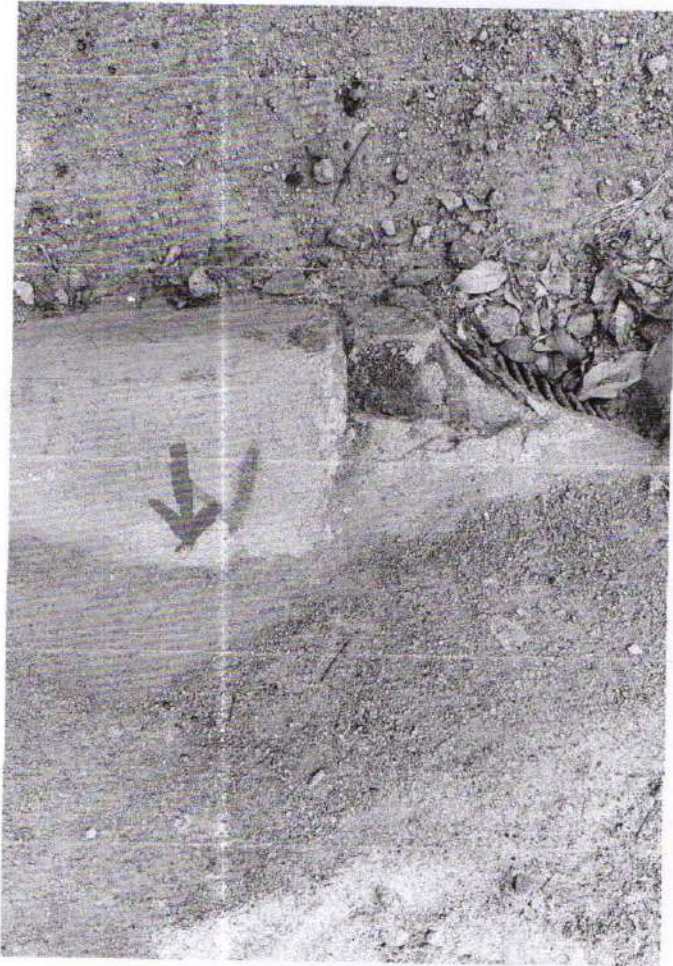
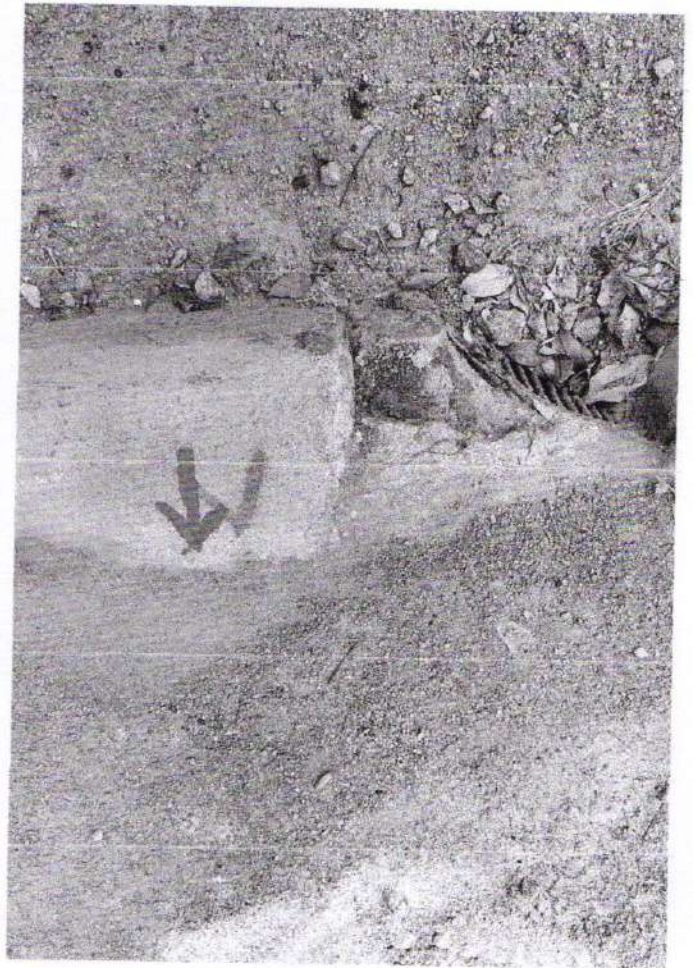
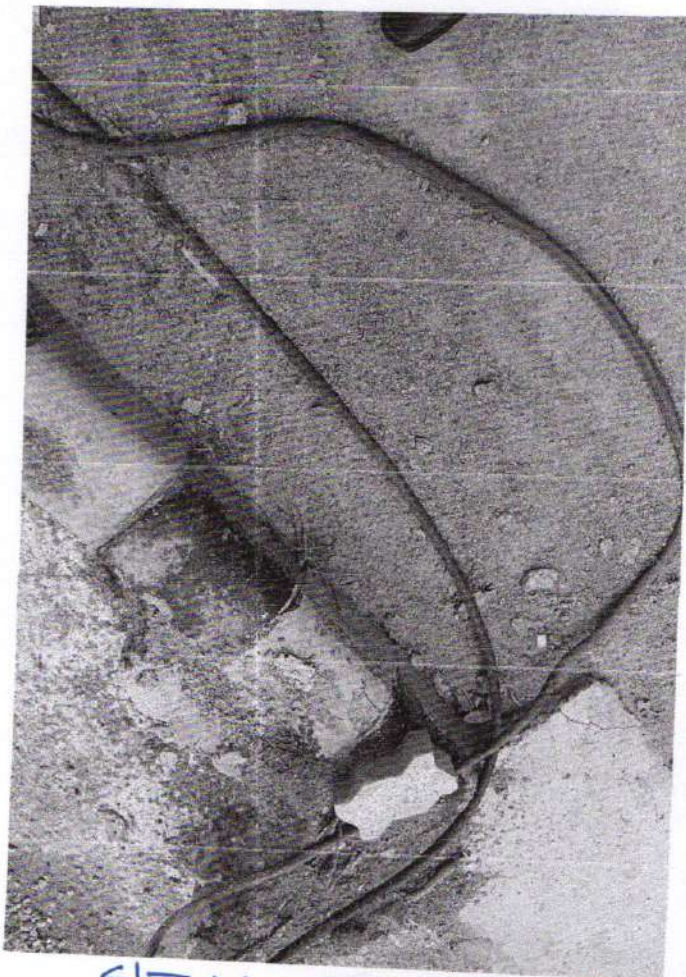
Slotted hole Home pipe damaged

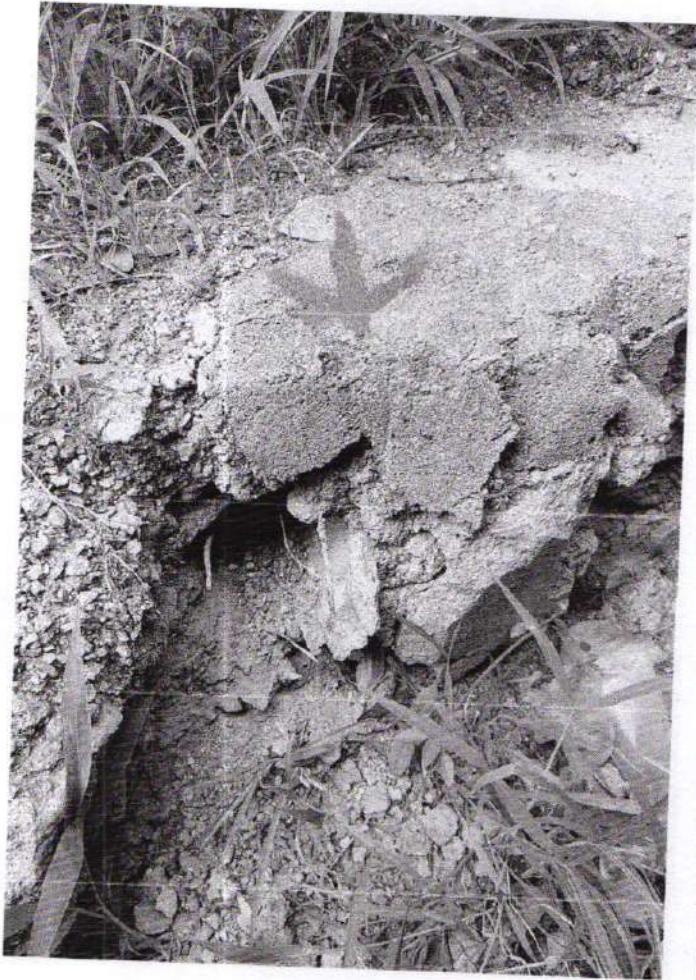
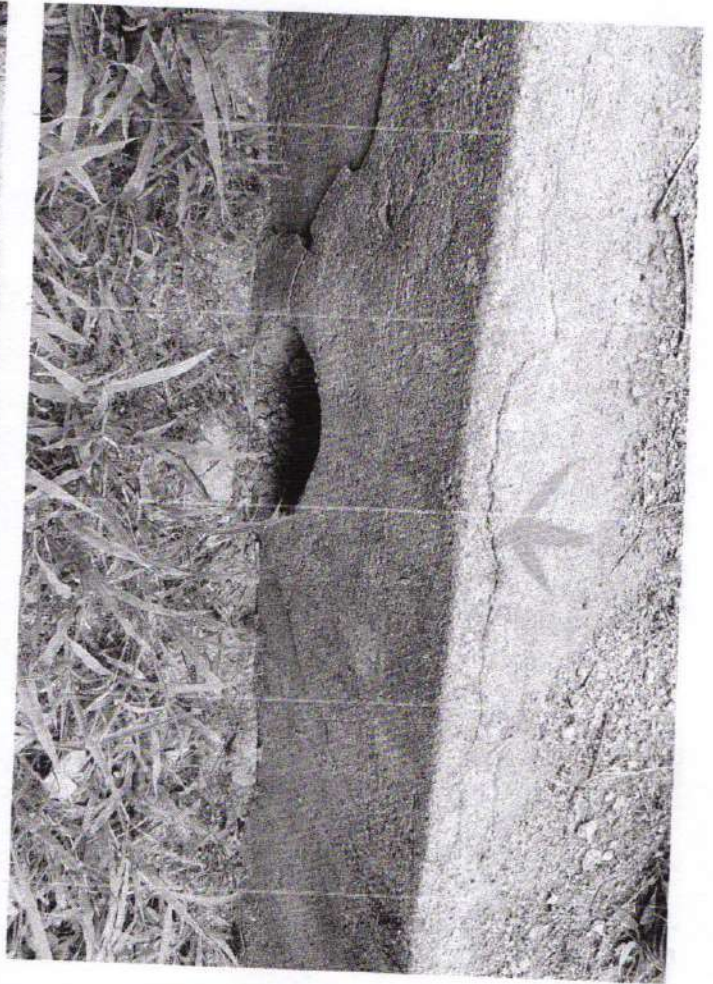
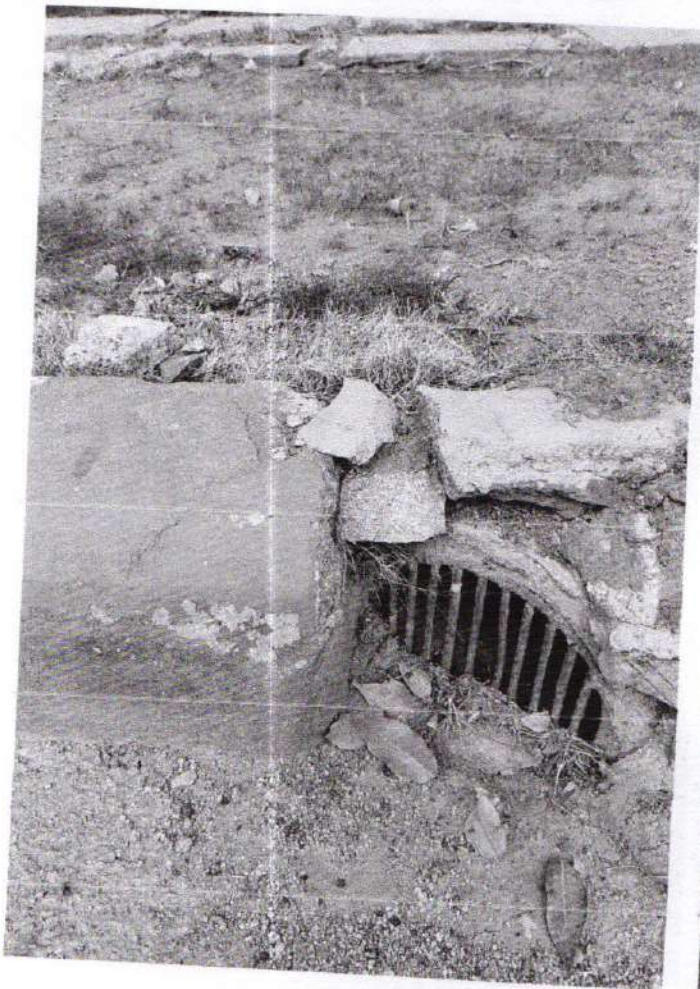
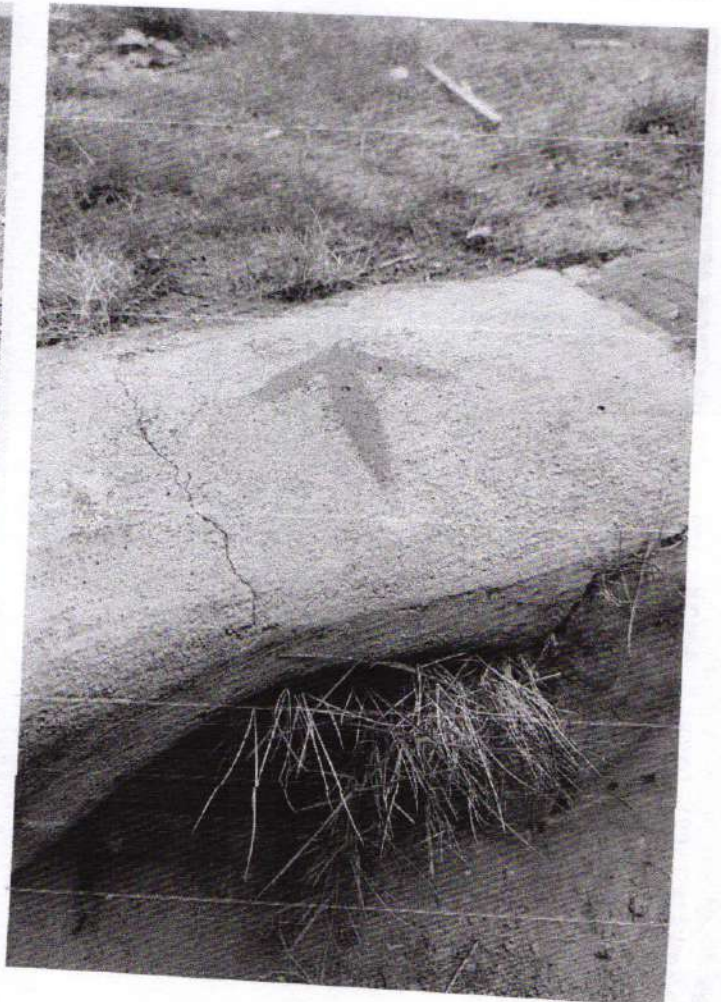
Home pipe damaged

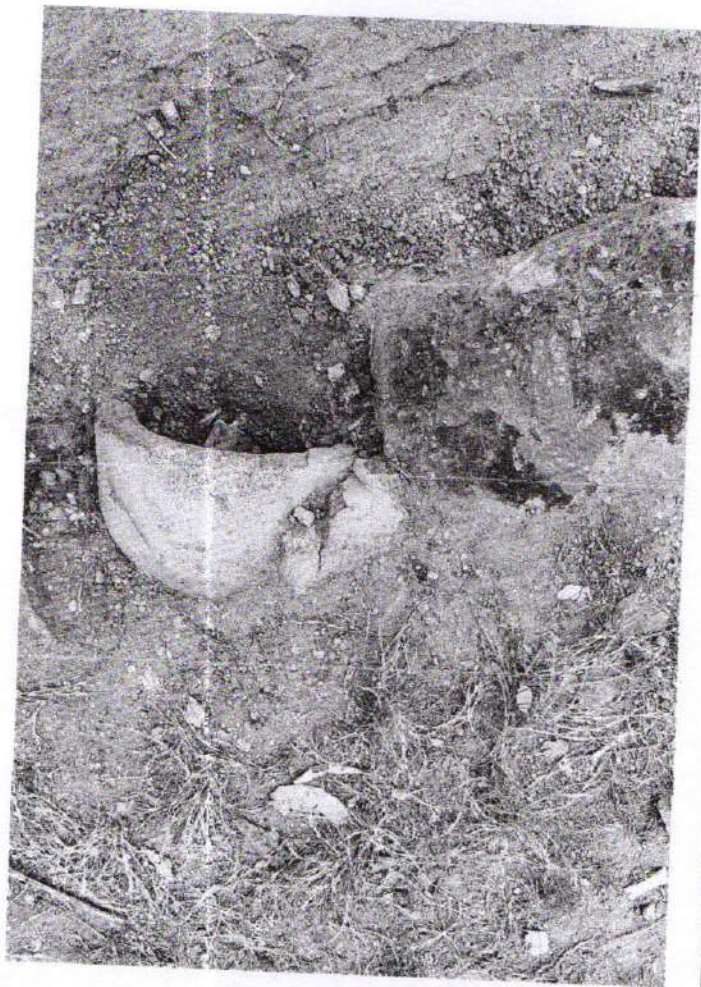
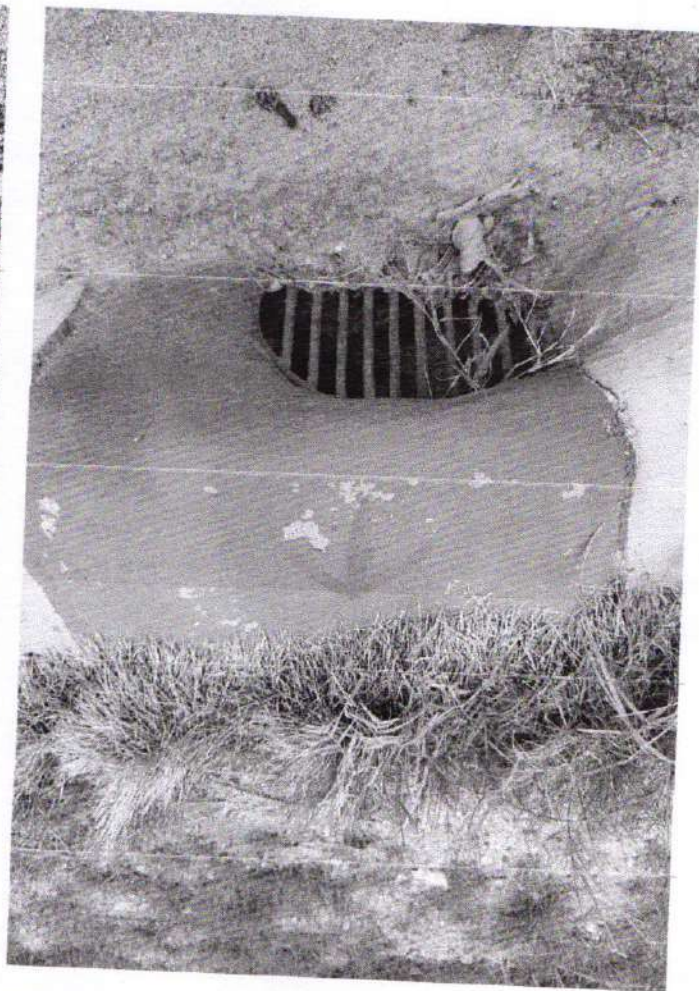
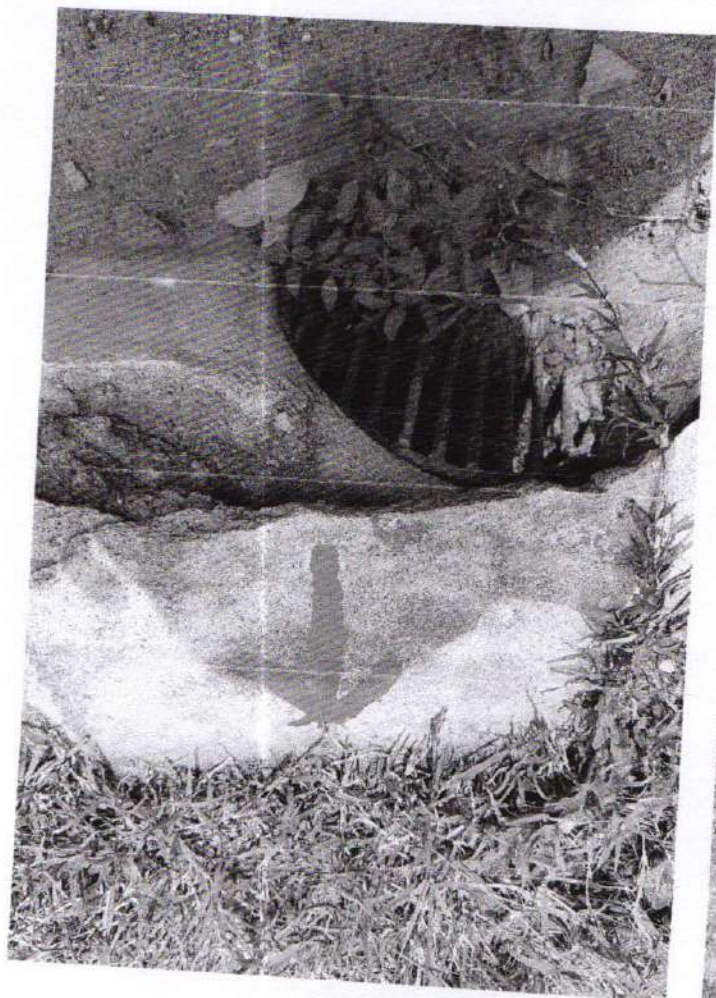
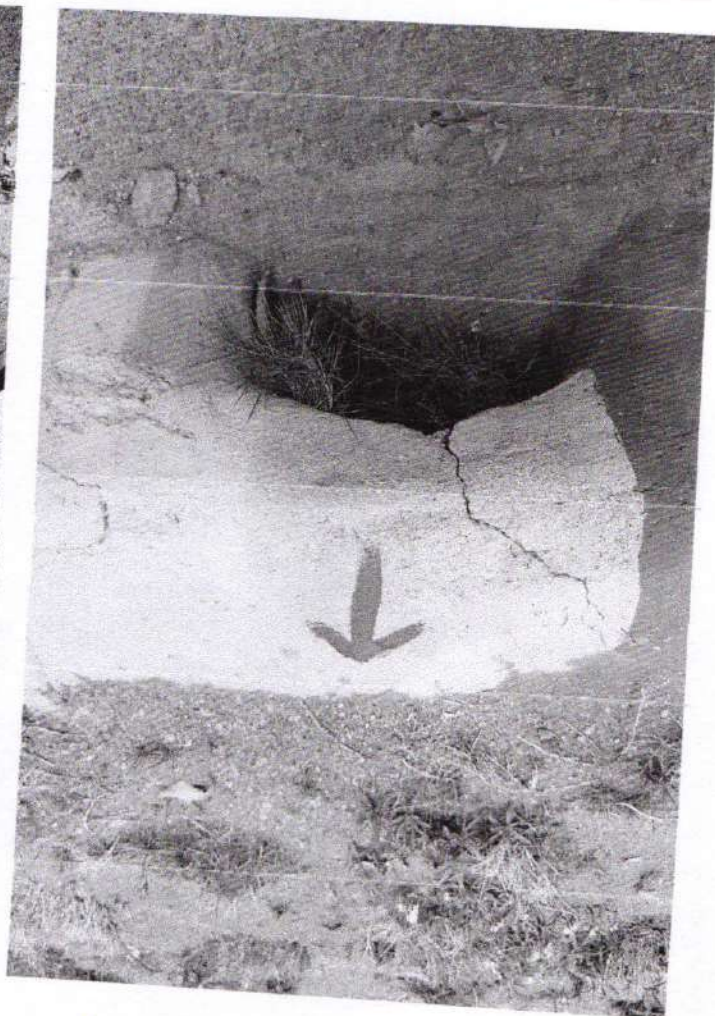
Storm water Humapores damaged.
