**Sub: CC.93/2024/TG-RERA - Meeting to Resolve  
Construction Defects.**

**Report on Issues Related to Expansion Joints and Water Leakage**

**Report on the Condition of the Building Corridor and Water Seepage Issues**

**Report on the Condition of the 1<sup>st</sup> Level Basement Parking**

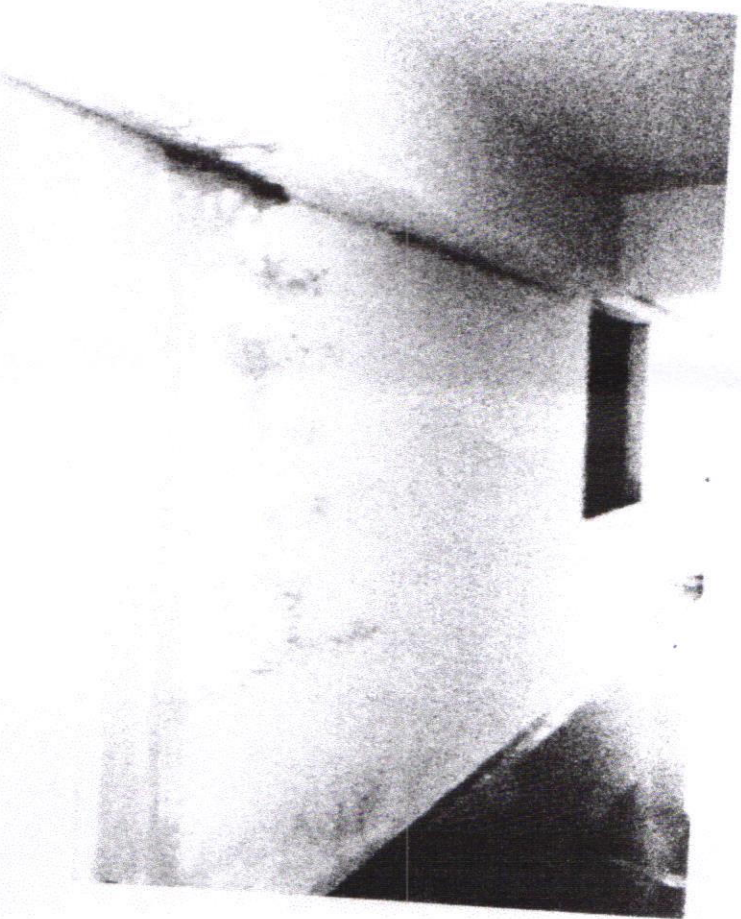
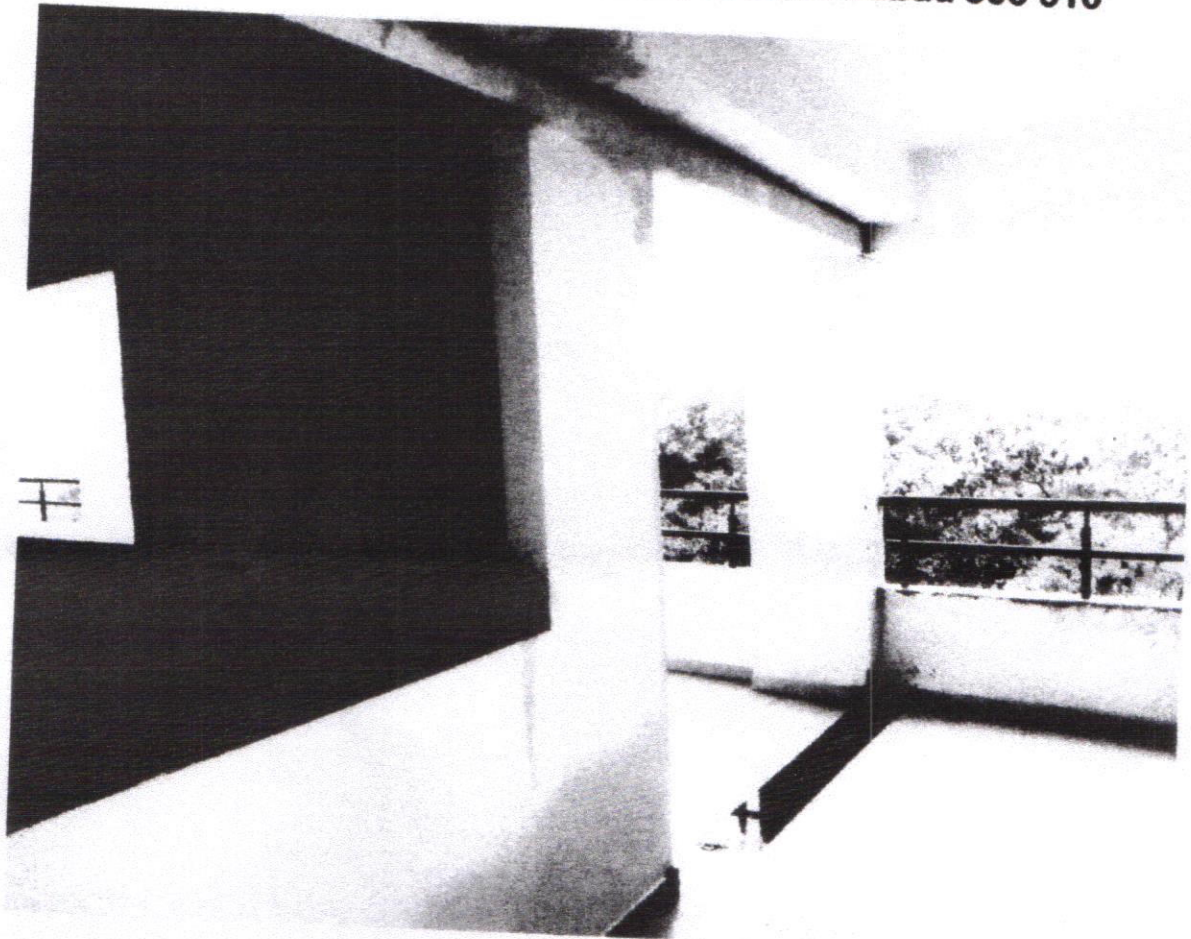
- The expansion joints have not been constructed as per the prescribed guidelines or standards, leading to water leakage during rains.
- Lack of adequate waterproofing materials or techniques in the original construction allows water to seep through the joints, causing severe structural damage over time.

During the rains (even for small-intensity rainfall), water penetrates through the poorly constructed expansion joints. The infiltration of water weakens the surrounding structural elements, causing potential long-term damage, including corrosion of reinforcement, damp patches on walls, and weakening of floors. Photos are attached for your reference (**Refer to Annexure A**).

After the residents filed a complaint under the Real Estate Regulatory Authority (RERA), the builder attempted to repair the joints by using white cement and granite. This method is not suitable for sealing expansion joints, as it neither provides the flexibility required to accommodate structural movement nor offers adequate waterproofing.

One effective and durable solution for arresting water seepage through expansion joints is the application of flexible waterproof expansion joint sealant. These sealants are designed to provide both waterproofing and flexibility, allowing the joint to accommodate structural movement without cracking or letting water through.

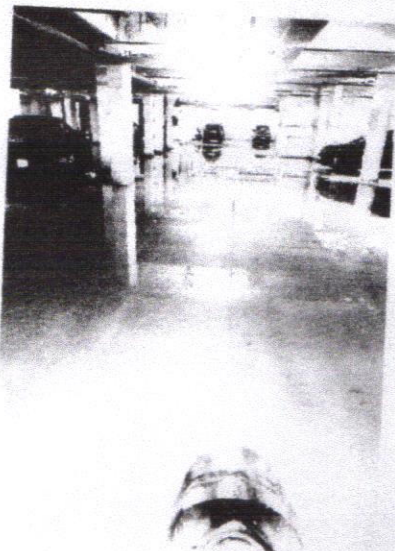
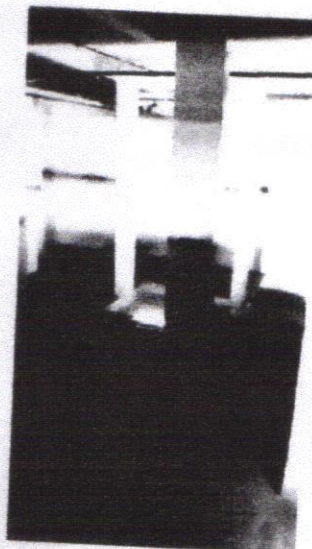
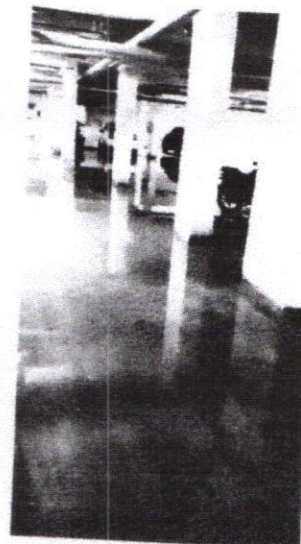
**Attachments:**

1. The primary issue observed is water accumulation in the entire 1st level basement. There is no visible provision for effective drainage of rainwater.

2. The stagnant water depth varies between 6 to 7 cm, indicating that the surface is almost uniformly flat, without the necessary slope required for water runoff.

4. Upon inspection, it is evident that the slope necessary to direct rainwater toward drainage points was not adequately implemented. Basement floors typically require a slope gradient of at least 1-2% toward designated drains to prevent water from pooling.

1. A professional contractor should be engaged to regrade the entire basement floor to provide an appropriate slope toward existing or newly installed drainage outlets. The slope should be at least 1-2% to ensure effective water flow.
2. If not already in place, install a comprehensive drainage system that includes floor drains at strategic locations throughout the basement, connected to stormwater management systems.
3. Regular maintenance and cleaning of drainage outlets to prevent clogging.
4. Waterproofing of basement walls and floors should be reviewed and repaired where necessary. This might include the application of waterproof membranes, sealing of joints, and injecting chemical waterproofing agents where seepage is evident.
