**MODI GREENWOOD HEIGHTS FLAT OWNERS**  
**Greenwood Heights, Kowkooor, Secunderabad 500 010**

**Sub: CC.93/2024/TG-RERA - Meeting to Resolve  
Construction Defects.**

**Report on Issues Related to Expansion Joints and Water Leakage**

**Report on the Condition of the Building Corridor and Water Seepage Issues**

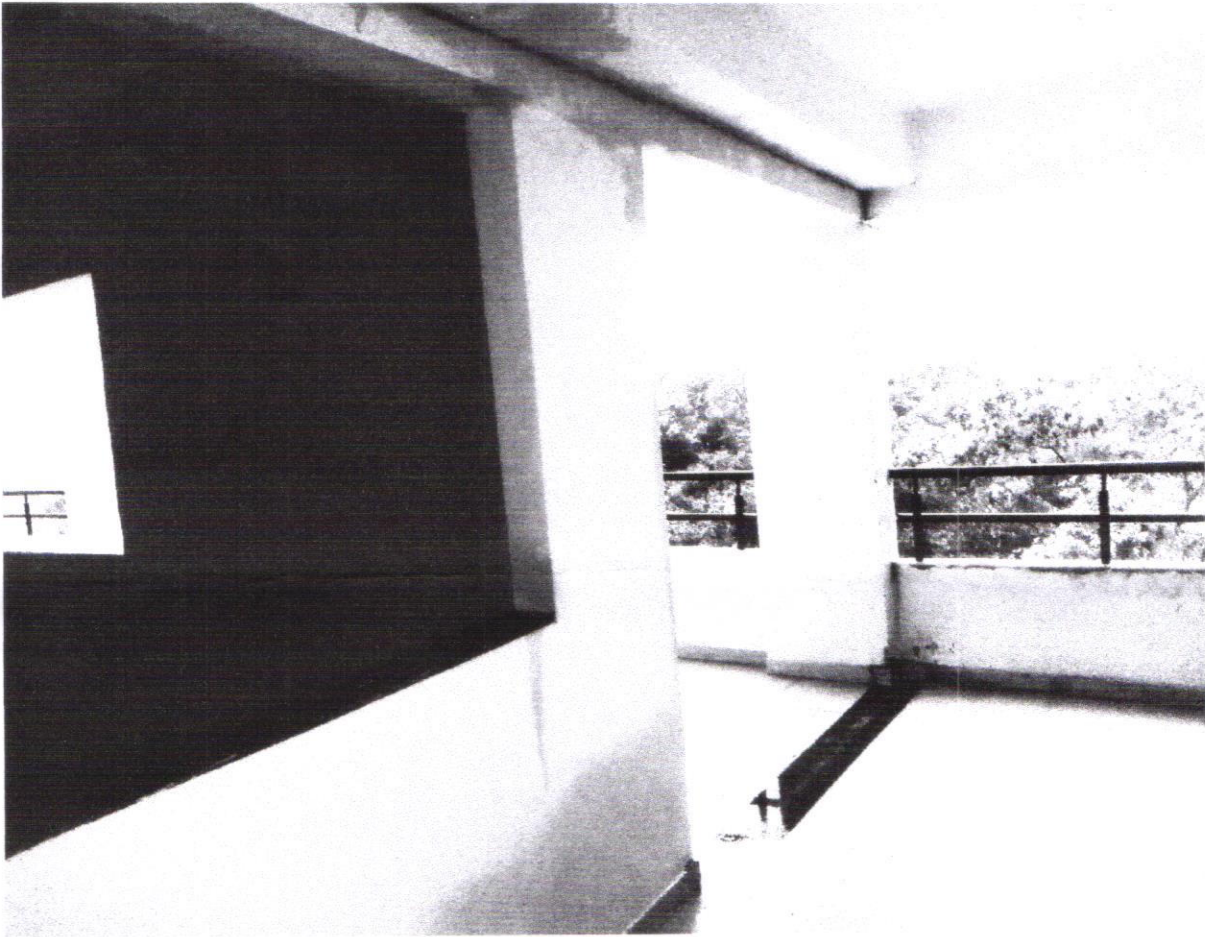
During the rains (even for small-intensity rainfall), water penetrates through the poorly constructed expansion joints. The infiltration of water weakens the surrounding structural elements, causing potential long-term damage, including corrosion of reinforcement, damp patches on walls, and weakening of floors. Photos are attached for your reference (**Refer to Annexure A**).

After the residents filed a complaint under the Real Estate Regulatory Authority (RERA), the builder attempted to repair the joints by using white cement and granite. This method is not suitable for sealing expansion joints, as it neither provides the flexibility required to accommodate structural movement nor offers adequate waterproofing.

Such an approach is deemed ineffective and could potentially worsen the problem by trapping moisture within the structure, leading to accelerated damage.

One effective and durable solution for arresting water seepage through expansion joints is the application of flexible waterproof expansion joint sealant. These sealants are designed to provide both waterproofing and flexibility, allowing the joint to accommodate structural movement without cracking or letting water through.

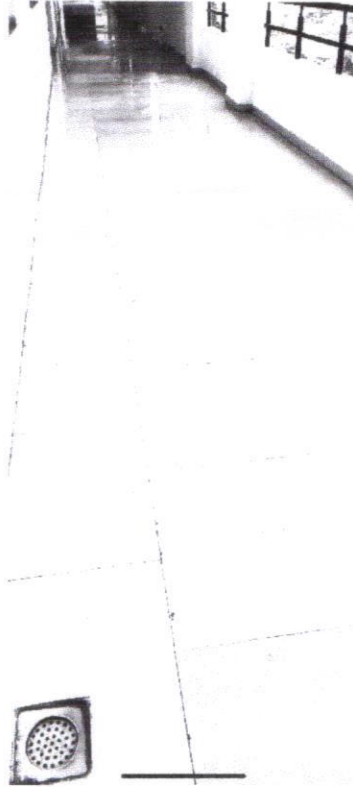
**Attachments:**

1. The corridor of the building has extensive waterlogging, with rainwater standing at a depth of 8 to 10 cm. This indicates the absence of an adequate drainage system to channel rainwater away from the corridor.

3. During heavy rainfalls, the water accumulates across the corridor, leading to pooling over the entire surface.
4. There is significant rainwater seepage occurring from the 7<sup>th</sup> floor down to the second level basement. This indicates a critical waterproofing failure in the external walls or roof slab of the building, causing water to penetrate the structure.

6. Water is observed dripping into the second basement parking, creating pools and potentially affecting the structural elements of the building below.

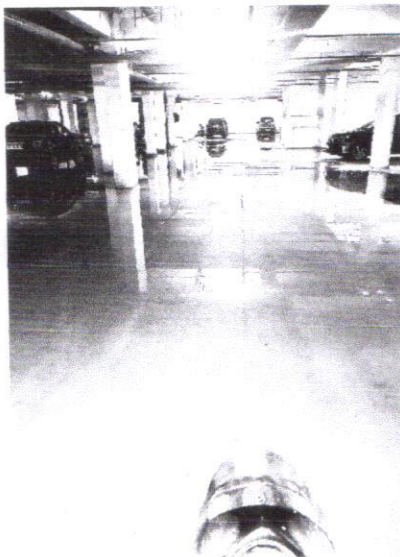
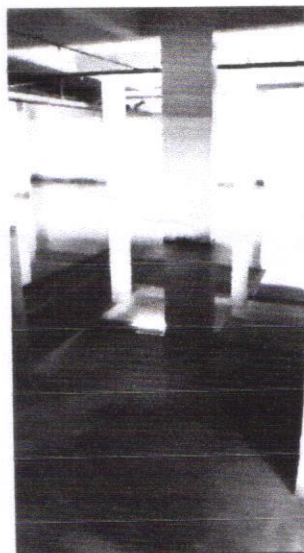
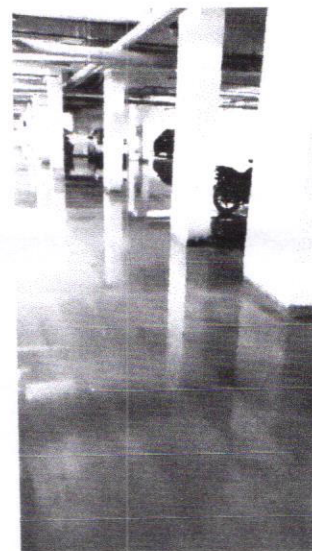
#### **Attachments:**

1. The primary issue observed is water accumulation in the entire 1st level basement. There is no visible provision for effective drainage of rainwater.

2. The stagnant water depth varies between 6 to 7 cm, indicating that the surface is almost uniformly flat, without the necessary slope required for water runoff.

4. Upon inspection, it is evident that the slope necessary to direct rainwater toward drainage points was not adequately implemented. Basement floors typically require a slope gradient of at least 1-2% toward designated drains to prevent water from pooling.

1. A professional contractor should be engaged to regrade the entire basement floor to provide an appropriate slope toward existing or newly installed drainage outlets. The slope should be at least 1-2% to ensure effective water flow.
2. If not already in place, install a comprehensive drainage system that includes floor drains at strategic locations throughout the basement, connected to stormwater management systems.
3. Regular maintenance and cleaning of drainage outlets to prevent clogging.
4. Waterproofing of basement walls and floors should be reviewed and repaired where necessary. This might include the application of waterproof membranes, sealing of joints, and injecting chemical waterproofing agents where seepage is evident.
