**From:** BnC estates [mailto:bnc@modiproperties.com]  
**Sent:** 01 11 2017 02:43 PM  
**To:** sohammodi@modiproperties.com  
**Cc:** Subbareddy BNC <subbareddy@modiproperties.com>; BnC Estates <bnc@modiproperties.com>  
**Subject:** Reg:Water Seepage along retaining wall and at Expansion join of E-Block.

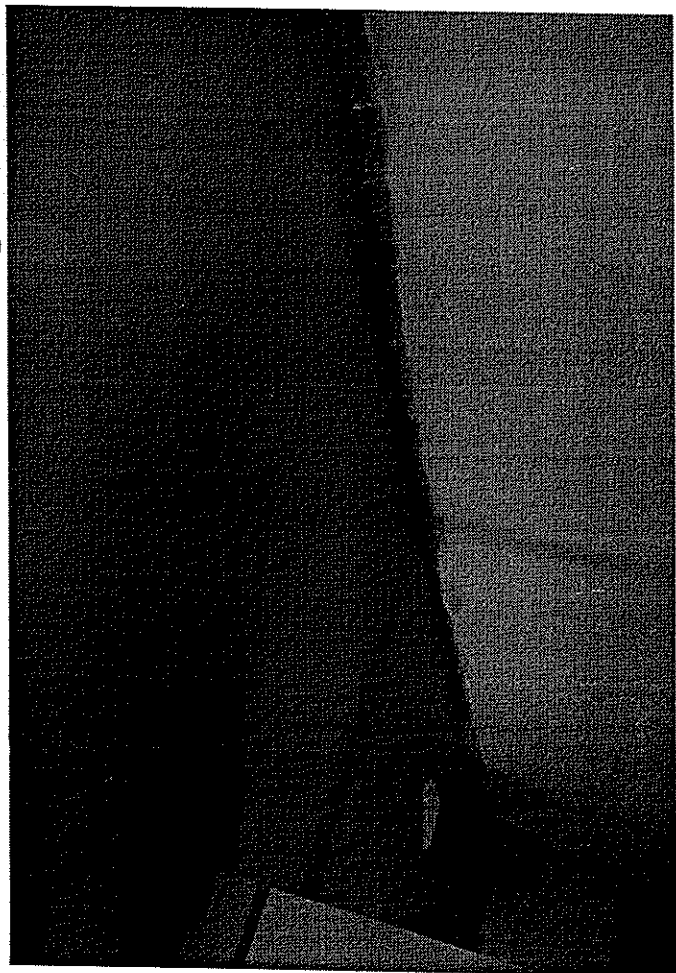
This is regarding seepage in E-Block sub Cellar floor. Sir, after close observation we have found that there is continuous seeping of water in to sub cellar along E-Block retaining wall at 2 locations of 30 feet length. Seepage is through minute pores along the flooring and retaining wall joint. This continuous seepage is the reason for water in sub cellar floor.

There is continuous water coming out from expansion joint at column joint.

Brick work and plastering of joint has no effect on seepage.
