Fw: Geologist , Ground Water Consultant

Subject: Geologist , Ground Water Consultant

Name M/s Gulmohar Residency  
Location: Mallapur  
SITE-1

PROPOSED RESIDENTIAL APARTMENT  
 FOR MODI PROPERTIES AT MALLAPUR, HYD.

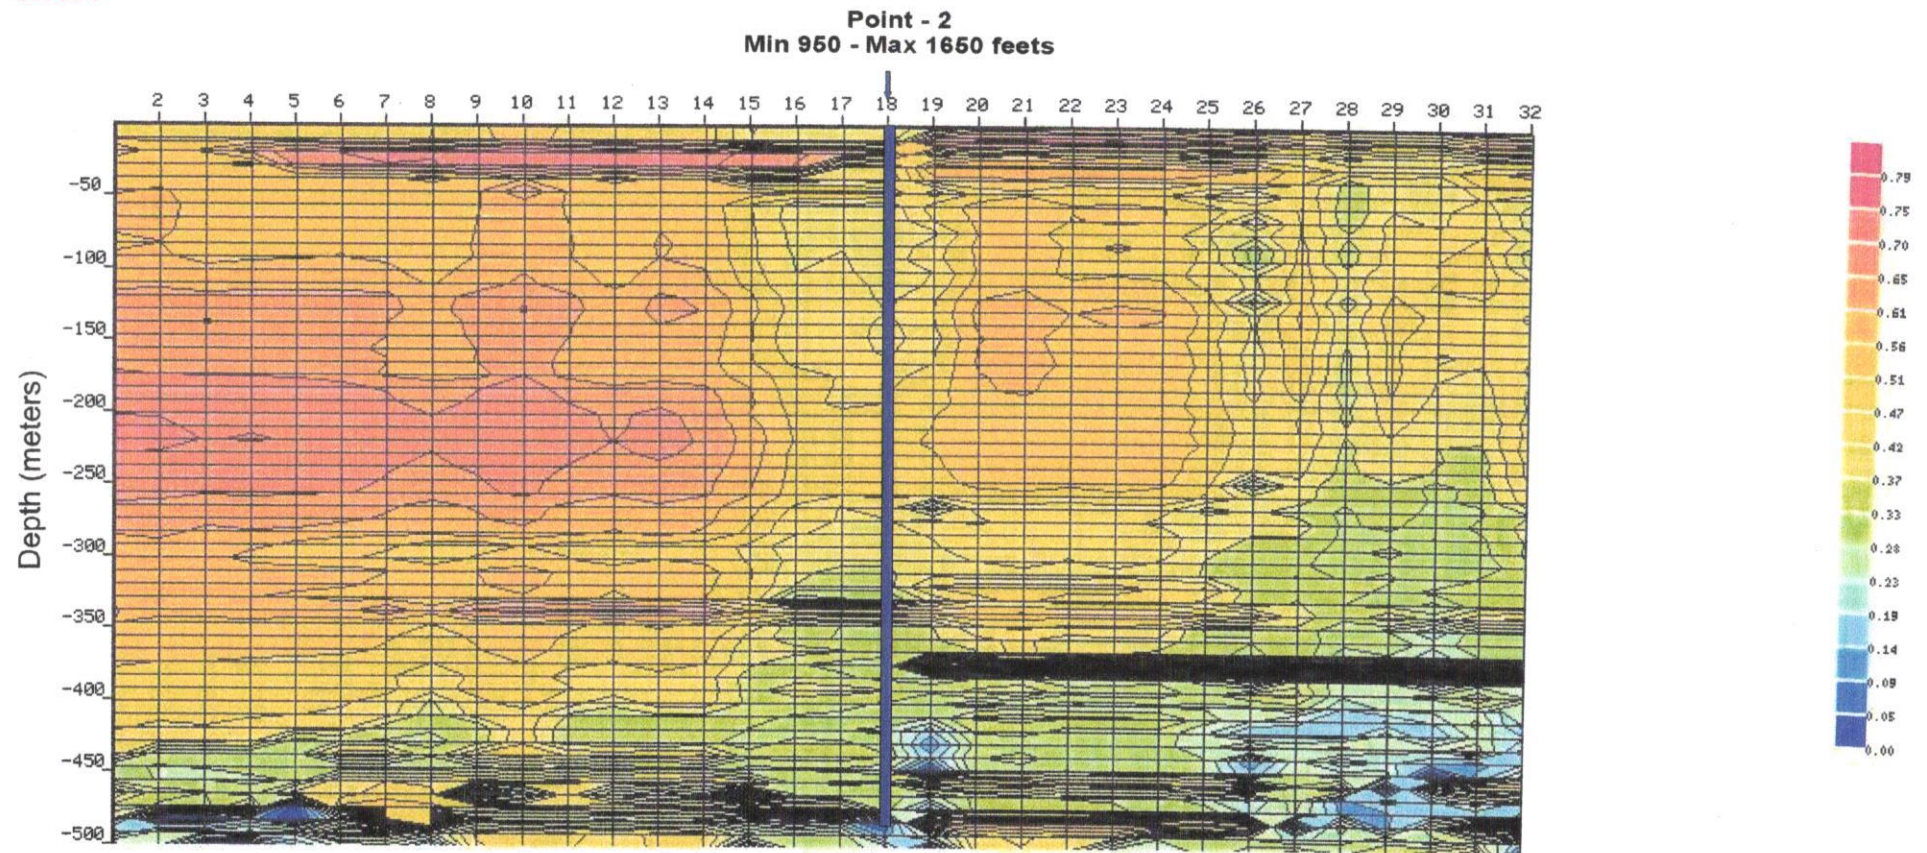
Note: Gt1180 profile min 950 - max 1650 feet need to drill at point-2.

**Point-2 :** Fractures observed at the depth 850-950 feet and 1550-1650 feet **(First Priority)**

**Please Note:** As per geophysical data 1.0" water possible at point - 2 . Seasonal variation will be there in water quantity.

Black/Blue granite exist then chances of dry fractures will be more.

100 % straight drilling is mandatory to touch deep fractures as fractures are small.

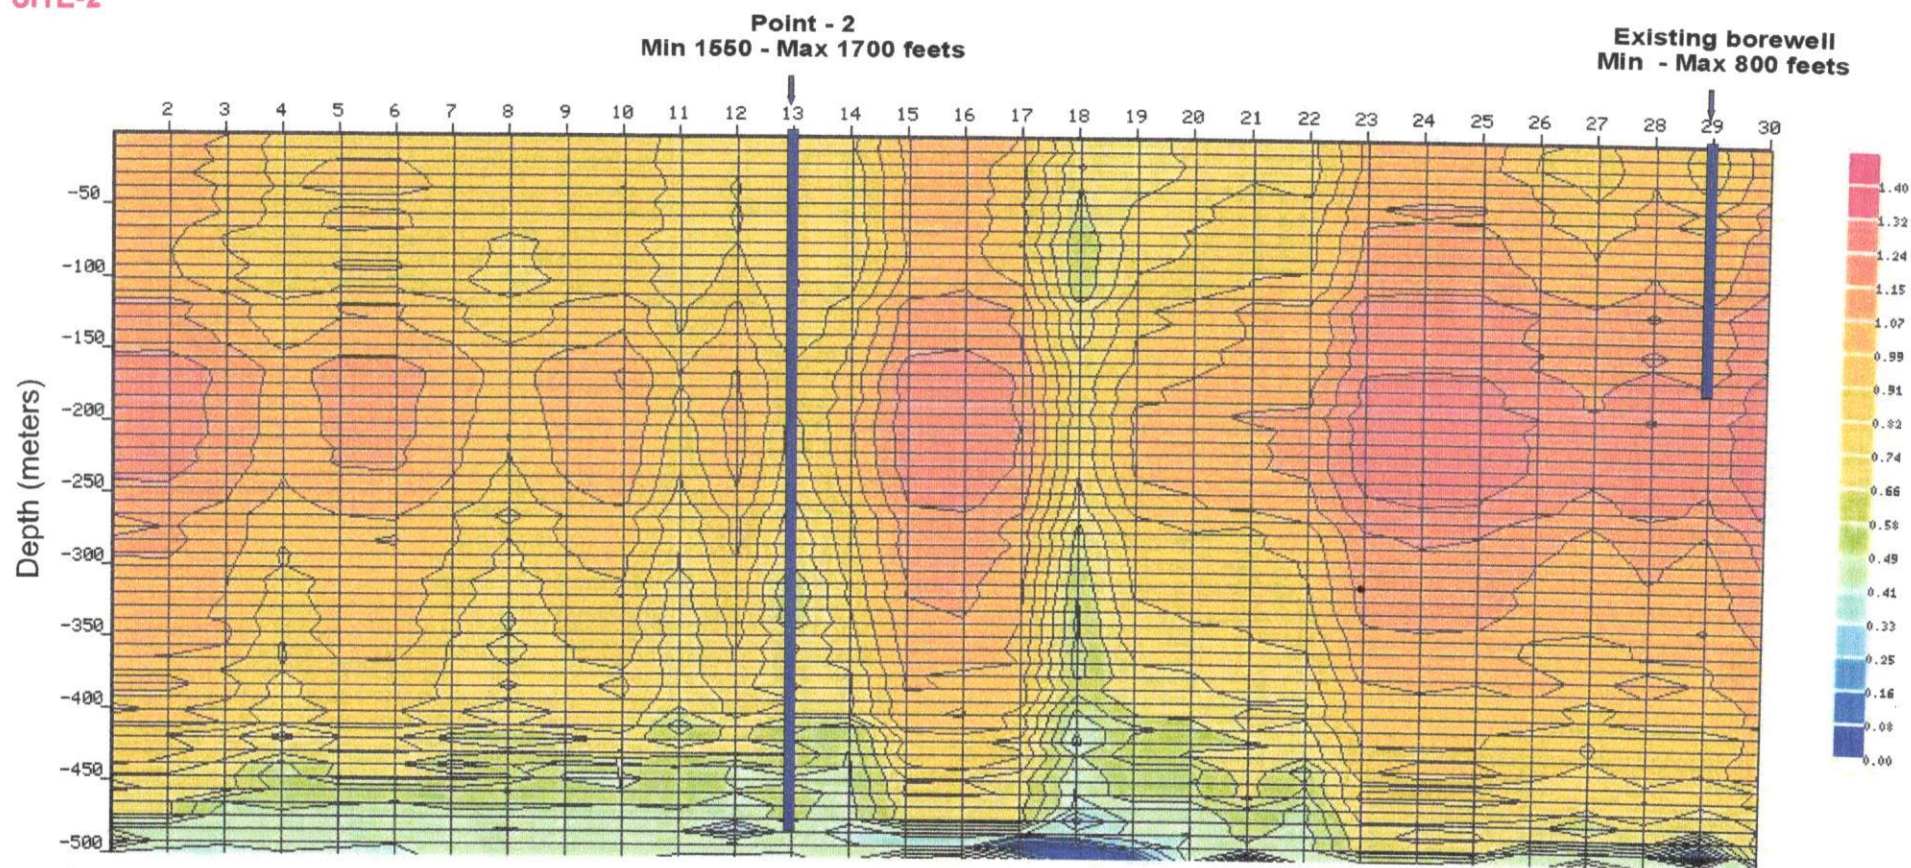
SITE-2

Note: Gt1181 profile min 1550 - max 1700 feet need to drill at point-2.

**Point-2 :** Fractures observed at the depth 850-950 feet (Dry/ seasonal water possible), 1450-1550 feet and 1600-1700 feet **(First Priority)**

**Existing Borewell :** Fractures observed at the depth 50-150 feet (seasonal water possible) and 700-800 feet (small fracture) **(Redrilling not suggested)**

**Please Note:** As per geophysical data 1.0" water possible at point - 2 . Seasonal variation will be there in water quantity.  
Black/Blue granite exist then chances of dry fractures will be more.

**100 % straight drilling is mandatory to touch deep fractures as fractures are small.**
